State of California  
The Resources Agency  
DEPARTMENT OF WATER RESOURCES  
DIVISION OF SAFETY OF DAMS

INSPECTION OF DAM AND RESERVOIR IN CERTIFIED STATUS

Name of dam Oroville Dam Dam No. 1-48 County Butte  
Type of dam Earthfill Type of Spillway Gated Concrete Weir and Chute  
Water is 70.8 feet below spillway crest and 179.5 feet below dam crest.  
\*Elevation 752.52 feet (above,below) (above,below)

Reason for inspection Periodic Evaluation (inspection 1 of 2)

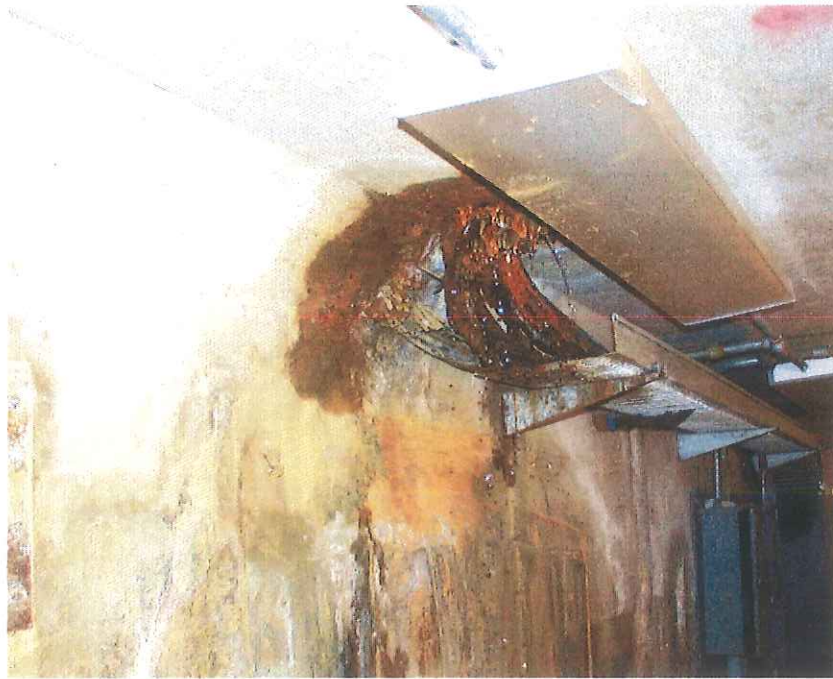
Oroville Dam, No. 1-48  
Photograph 1 1/10/01

17	<p><u>Seepage</u> - Seepage in the gallery was minimal due to the low reservoir.</p>
18	<p><u>Instrumentation</u> - was inspected. The Terminal S piezometer tubes were recently cut at the crown of the tunnel and now drain directly to the floor, see photograph 1. A collection system will be installed to direct the flow to the floor drain system. Turbidity is measured regularly, although sediment transport does not appear to be a problem.</p>

Formerly, a number of piezometers were read at Terminal S within the foundation gallery. For the last several years these piezometers provided little useful information. Last year the tube bundle and mounting rack were removed as shown. The seepage from the tubing passes directly to the floor. Turbidity is measured regularly, although sediment transport doesn't appear to be a problem.
